A.3 POLYSTEEL FORMS PRODUCE STRONGER WALLS

A.3.1 POLYSTEEL FORMS AS SHEAR WALLS

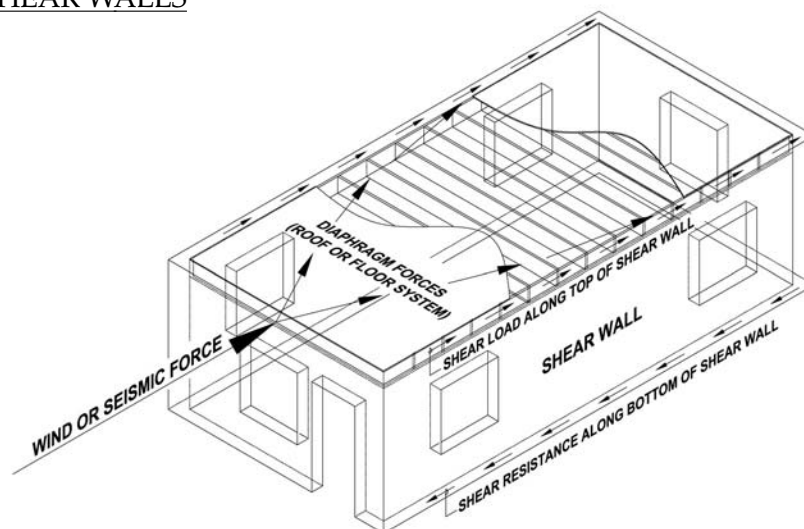
Figure 1.2 SHEAR WALLS

A shear wall is a wall designed to resist lateral (side) forces that are parallel to the plane of the shear wall. In a house or commercial building, each wall can act as a shear wall that braces the adjacent perpendicular walls from the forces of wind, earthquakes, etc. For example, if a west wind is blowing against the west wall of a house, the two adjacent perpendicular walls help brace the west wall to keep it from blowing over (See [Figure 1.3](#) below). The two “bracing walls” are acting as shear walls. In a wood frame structure, for example, walls are braced against wind forces by nailing plywood to the frame of the exterior perpendicular walls for added strength (In reality, every wall in a structure can act as a shear wall to brace the perpendicular walls).

The extraordinary strength of PolySteel walls allows them to perform exceptionally well as shear walls. If more shear strength is required, additional horizontal rebar can be placed within the wall for reinforcement. As a result, PolySteel walls can be easily designed to provide shear wall strength of 3,000 to 10,000 pounds per lineal foot of wall. This makes PolySteel an ideal product for buildings in severe weather areas and safe rooms integrated into the design of structures where life-threatening weather conditions, such as hurricanes, tornadoes, or earthquakes, present a threat. A good example of the shear strength performance of a PolySteel building is a five-story beach front condominium, built on the edge of the Atlantic Ocean in Daytona, Beach, Florida. Constructed in 1981, this structure has successfully withstood the force of numerous major hurricanes, while providing its occupants with safety and security.
